Pre-inspection of turbocharger hot-parts

Service Letter

June 2023

Owners and operators with MET axial turbochargers

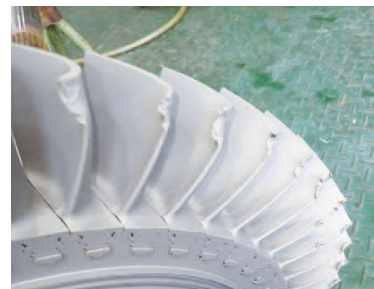
According to the manufacturer's experience, aged deterioration of wear parts that have been exposed to exhaust gases (turbine blades, nozzle ring and gas outlet guide) is frequently observed after around 10 years in operation. This deterioration will become a contributing factor to degradation of the turbocharger performance.

Guiding overhaul and expected service life of MET turbocharger hot-parts

For this reason, it is recommended to conduct an inspection of the turbocharger turbine side 4-3 months ahead of the scheduled major overhaul.
