ALERT Service Bulletin – Product Recall Action – ASB2009/12/23

SL10-531/BTT

Owners and Operators of MAN
Four-stroke Diesel Engines installed
with TCR16, TCR18, TCR20 and
TCR22.

Alert SB-Nr.:	ASB2009/12/23
Subject	Product recall of TCR16, TCR18, TCR20, TCR22 turbochargers Improvement of connection of bearing casing and compressor casing
Serial Numbers concerned	all
Reason	<p>During the development of the TCR turbochargers the containment safety of the existing flange connection was thoroughly proven by simulations and tests.</p> <p>Nevertheless operation in field has shown in singular cases a damage of the compressor wheel, which was initiated by foreign object impact. This caused a failure of the flange connection. As a consequence fragments of the compressor wheel could be released.</p> <p>For this reason the design of the flange connection was optimized in order to safeguard the containment safety even under circumstances as described above. This optimization regarding the containment safety of the TCR16, TCR18, TCR20 and TCR22 turbochargers by installation of the modified clamping claws and screws is now specified by MAN Diesel.</p>

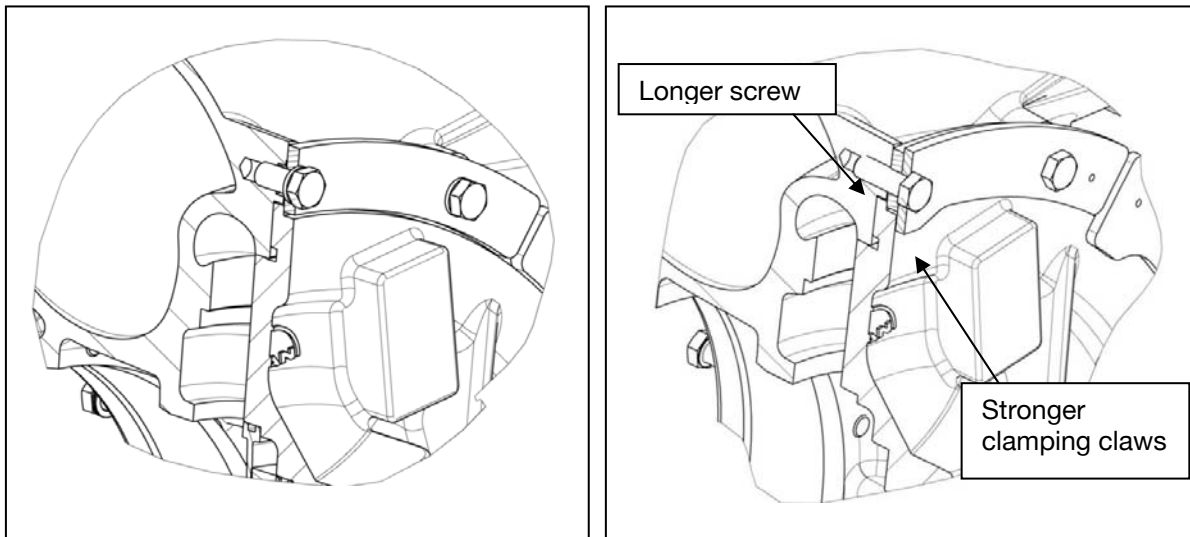
Figure 1. previous flange connection

Operation in the field has shown a damage of the compressor wheel in singular cases, which was initiated by foreign object impact. This caused a failure of the flange connection. As a consequence fragments could be released. For this reason the design of the flange connection has been optimized in order to safeguard the containment safety even under circumstances as described above.

Figure 1 shows the new design flange connection.

improved flange connection

Compliance	Mandatory
Description	<p>The turbocharger must be updated to an improved flange connection. The clamping claws were stiffened by the application of a second layer of claws. The new design has also stronger and longer screws. On the majority of the turbochargers this update can be carried out by the crew during a normal harbour stop. In few cases the update is more extensive and has to be carried out by qualified personnel.</p> <p>In order to exclude all eventualities: As long as the above described conversion has not been carried out we strongly demand to advise the crews on board of the affected vessels not to stay in the engine room as long as the engine operates above 80% load. For all other load profiles no person shall as usual stay unnecessarily in the danger zone of the turbochargers during operation (according to TC manual).</p> <p>After the conversion please refer to the normal safety instructions in your manual.</p>
