## **ALERT Service Bulletin – Product Recall Action – ASB2010/03/01**

SL10-532/BTT

Owners and Operators of MAN  
Four-stroke Diesel Engines installed  
with TCR20, TCR22 and NR12/S.

<b>Alert SB-Nr.:</b>	ASB2010/03/01
<b>Subject</b>	<b>Product recall of TCR20, TCR22 and NR12/S turbochargers</b> Improvement of shaft sealing on turbine side
<b>Serial numbers concerned</b>	<b>NR12/S:</b> all <b>TCR20:</b> 7 000 329-678, 7 020 640/641, 7 021 532/533, 7 021 535, 7 020 656-658, 7 020 664-747, 7 022 144-569, 7 023 280-690, 7 024 008-934, 7 025 643- 826, 7 026 113-988, 7 027 765/766, 7 028 066-307, 7 520 934, 7 522 399/400, 7 523 442 <b>TCR22:</b> 7 000 303-664, 7 021 384-485, 7 021 698-953, 7 022 052-632, 7 023 516, 7 023 518-913, 7 024 066-909, 7 025 070-855, 7 026 536-916, 7 027 209- 983, 7 110 075, 7 648 149
<b>Reason</b>	During the development of the TCR and NR/S turbochargers the shaft sealing on the turbine side was thoroughly proven by simulations and tests. Nevertheless operation in field has shown in some cases a malfunction/collapse of the shaft sealing, with the consequence of a severe oil leakage on turbine-side. A new shrink fitted locating ring design on the turbine sided

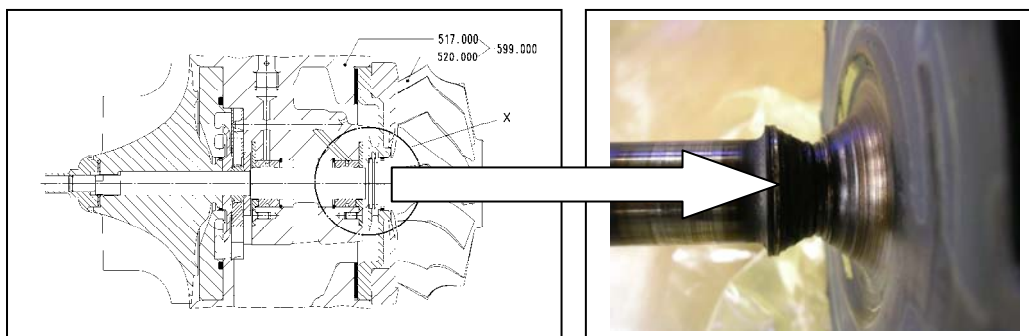
<b>Compliance</b>	<b>Mandatory</b>
<b>Description</b>	We identified in certain productions lots (above mentioned) of TCR20, TCR22 and NR12/S, that the piston ring groove is in the wrong position on the shaft. Therefore it can happen at certain operation load conditions that the turbine wheel material melts on the piston ring.

Figure 1: shaft grinding on the turbine shaft on a NR12/S turbocharger

In consequence of the damaged shaft sealing oil can enter the hot turbine inlet casing with the potential risk of a fire in the exhaust pipe or funnel. For this reason a new locating ring repair kit was designed which avoids this failure.

The above listed turbochargers must be updated to the improved shaft sealing with shrink fitted locating ring. For a better stiffness of the locating ring the diameter of the piston ring was increased. Therefore also the bearing casing must be updated. It is recommended to exchange the cartridge. This update has to be carried out by qualified personnel.

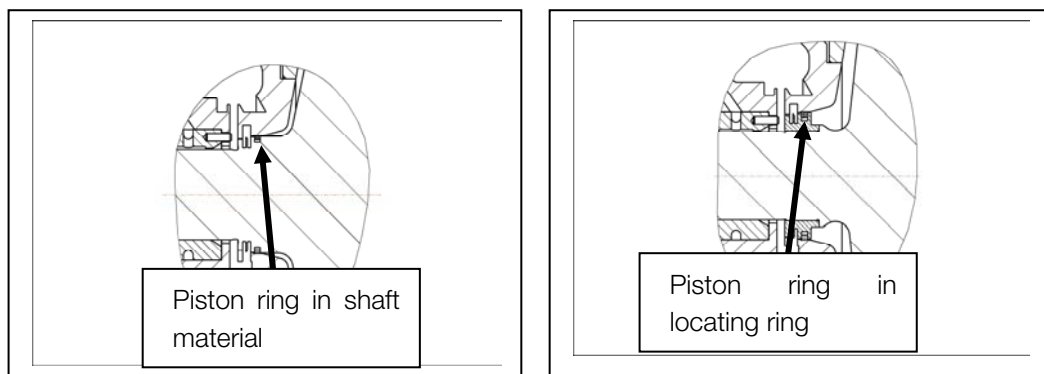
Figure 2: previous design

improved design
