Fatigue Piston Cracks on L23/30-series Engines

SL11-541/JXN
January 2011

Owners and operators of MAN four-stroke diesel engines.
Type: GenSets L23/30 series

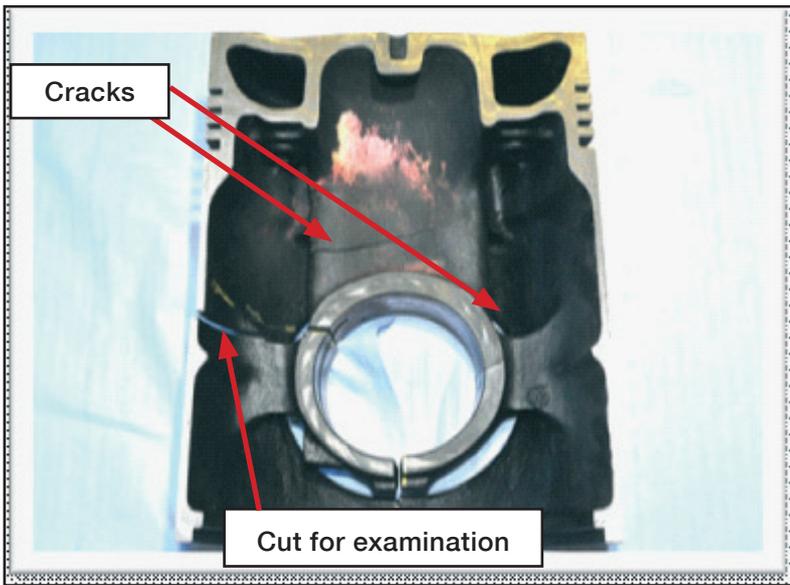
Figure 1

Pistons have been examined and it was found that the cracks originate from the ribs between the pin boss and the intermediate deck.

MAN-L23/30-series engines have proven its reliability and durability over the past decades. Nevertheless, MAN Diesel & Turbo never stopped pouring best efforts to improve the quality of the engines. As one of the results from such efforts, we have found that pistons equipped on L23/30 engines might have fatigue cracks. We have experienced such cracks after 20,000 running hours on few vessels, mainly tankers, which may potentially bring risk and consequential damage to the engine and endanger the health and life of persons who are around the engine.

In order to avoid unfortunate cases, MAN Diesel & Turbo offers a service package consisting of the overhaul inspection and replacement of pistons with reinforced new pistons by improved design. This service package is applicable to L23/30-series engines in service.

Upon this opportunity, we advise that all pistons must be inspected. Until then and if the pistons are not exchanged make sure that no person is standing or walking in or through the area on the exhaust side of the engine(s) during operation.
