**Valve Adjustment Procedure**

SL12-559/MIKA  
March 2012

GenSet L16/24, L21/31, L27/38

Enclosure:  
Working Card 508-01.10 (14)

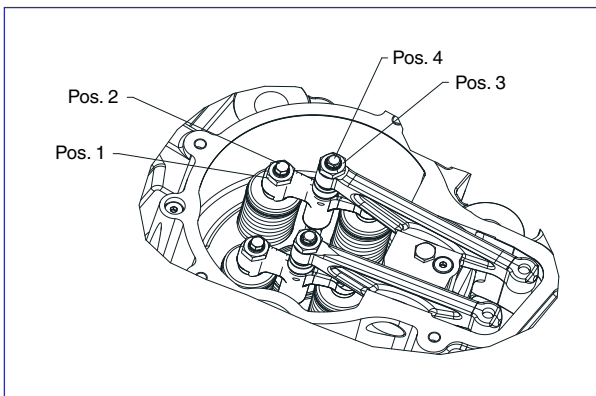
Fig. 1

1. Shut-off starting air and fuel oil.
2. Stop the lubricating oil circulation.
3. Dismantle the cylinder top cover.
4. Dismantle the clamp for non-turning bridge, if mounted (L16/24).
5. Turn the crankshaft until the cylinder is in ignition TDC (both valves closed).
6. Check that the surfaces are clean.
7. Loosen the counter nut, pos. 1, and the adjusting screw, pos. 2, on the valve bridge.

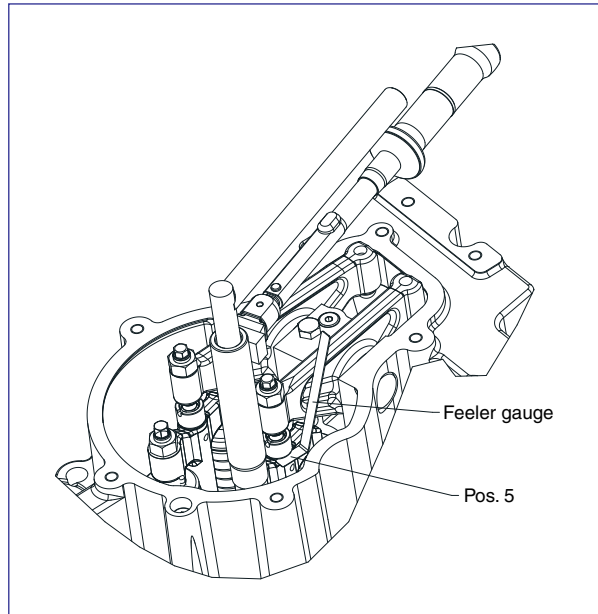
Fig. 2

8. Loosen the counter nut, pos. 3, and the adjusting screw, pos. 4, on the rocker arm and insert the feeler gauge between valve bridge and rocker arm, pos. 5.
9. Adjust the screw, pos. 4, on the rocker arm until the feeler gauge makes only slight resistance.
10. Tighten the counter nut, pos. 3, on the rocker arm with torque. Re-check that the feeler gauge clearance has not changed.

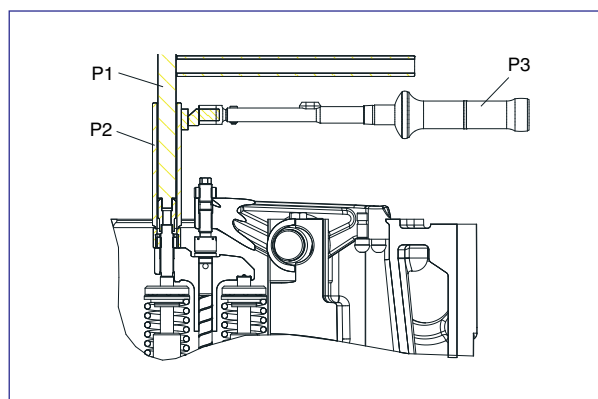
Fig. 3

11. Adjust the screw, pos. 2, on the valve bridge until the feeler gauge makes slightly more resistance, but it must still be possible to move the feeler gauge.
12. Tighten the counter nut, pos. 1, on the valve bridge with torque. Re-check that the feeler gauge clearance has not changed.
