Check of Camshaft Coupling

Fitted Bolts

SL2012-567/AAB
December 2012

Owners and operators of MAN B&W two-stroke marine diesel engines.
Type: MC and MC-C

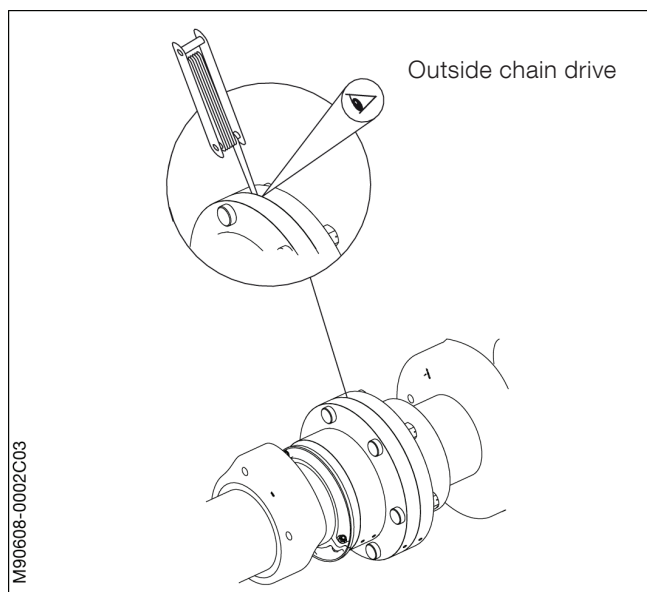
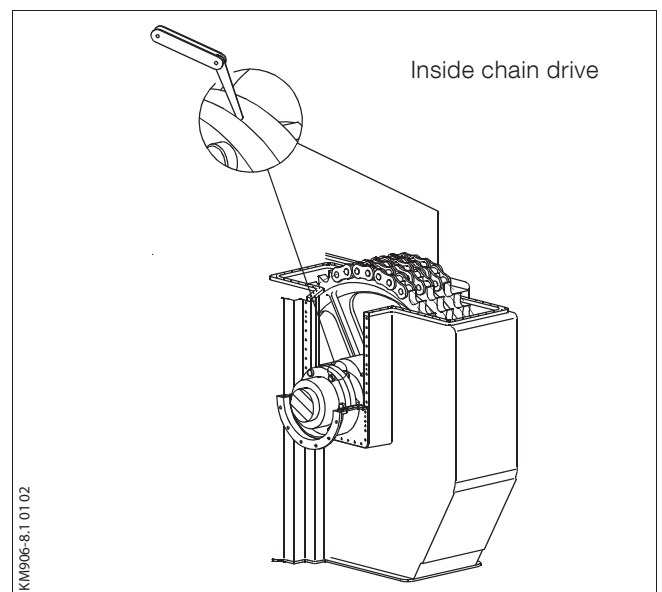
Fig. 2: Check with feeler gauge

Check the connection between the camshaft coupling flanges with a 0.05 mm feeler gauge.

If any gap can be measured on the entire circumference of the couplings, MAN Diesel & Turbo should be contacted for further instructions.

- The specified bolt torques for the individual engine type are listed in Fig. 1.
- If tension of the bolts is found to be less than 85% of the tension specified, the flange joint must be checked for gaps in accordance with Fig. 2 before and after retightening. The size of the gaps must be recorded.
- Before commencing the inspection, ensure that the specified torque spanner and necessary attachments are available according to the instruction book on board and the standard scope of tool supply.
- Ensure that the consequence diagrams in Figs. 3 and 4 are followed strictly, and record the inspection intervals and findings in the plant maintenance system on board.

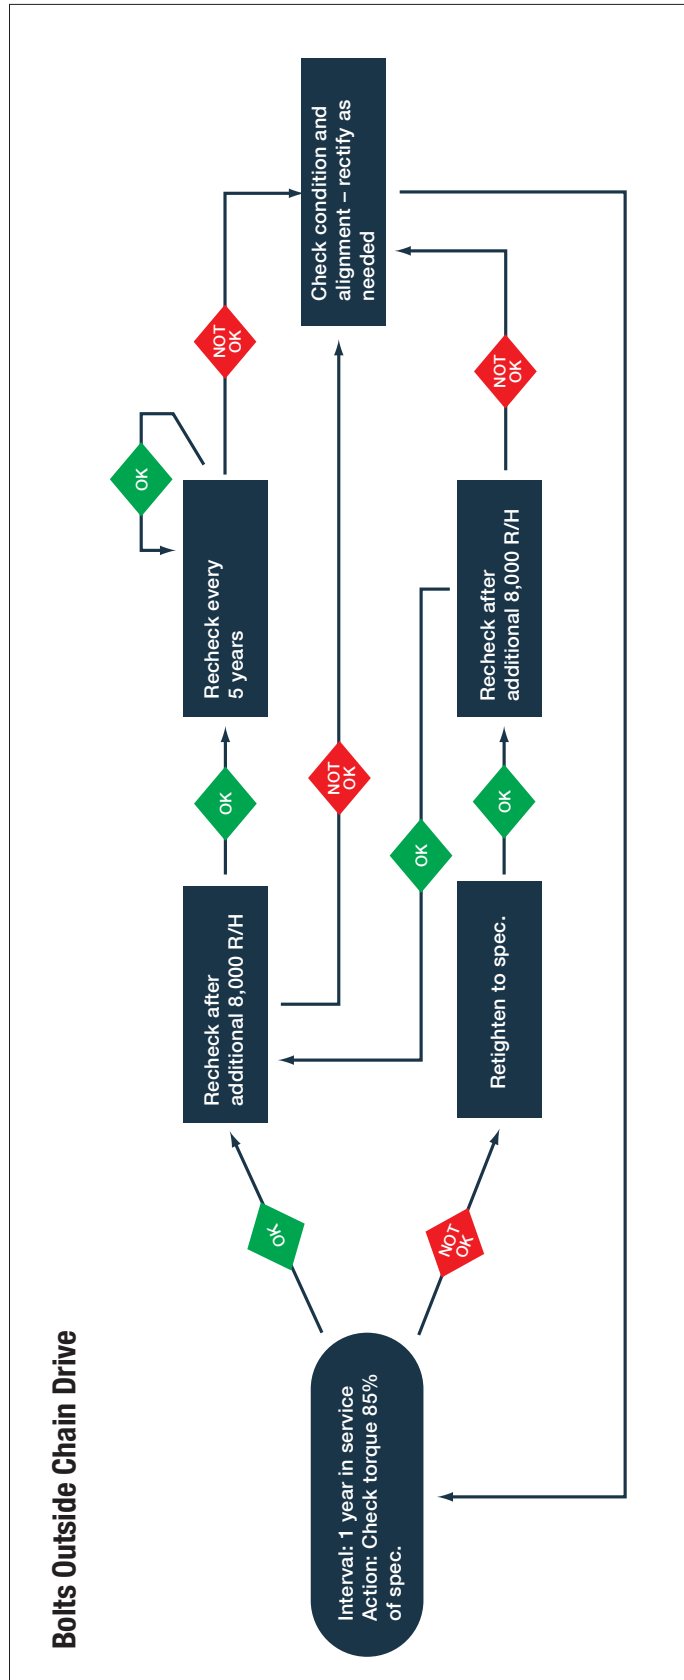
Fig. 3: Inspection scheme for bolts placed outside the chain drive

On the other hand, centre-mounted “non-adjustable” bearings are less prone to change their original position/height, unless wear in the camshaft bearings occurs. Wear in these bearings is rare and will only occur in case of severe oil contamination or otherwise deteriorated oil properties.

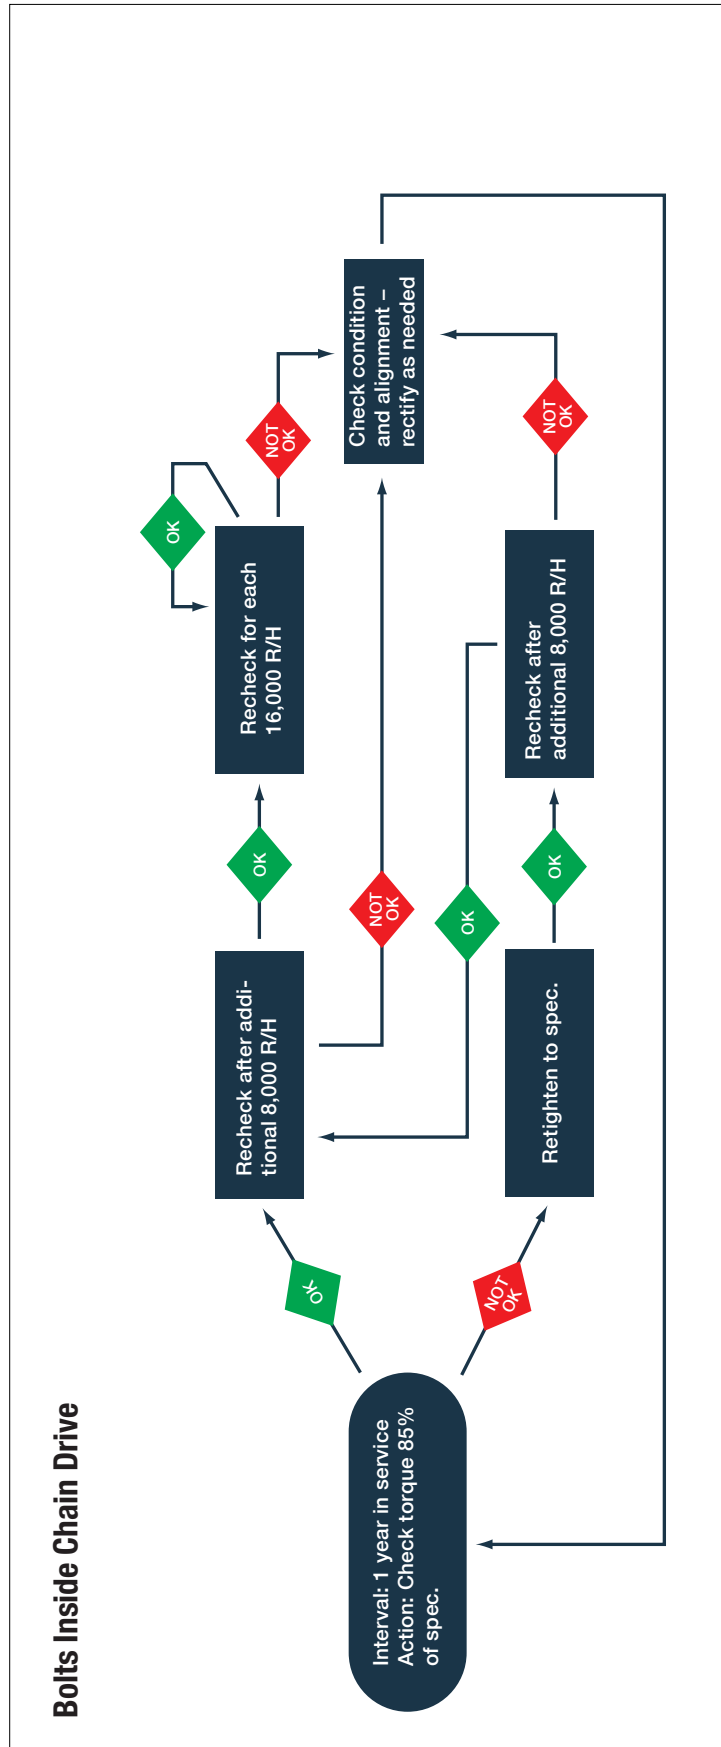
Fig. 4: Inspection scheme for bolts placed inside the chain drive

Because the bearings are adjustable, there is an elevated risk that they may have been incorrectly adjusted from the start. Another cause could be changes in service due to operational aspects, such as incorrect tensioning of the main chain(s), or changes to the original adjustment of the bearings by wear mechanisms caused by, for instance, off-spec. oil properties, or relative movement due to incorrect tension of the fixating bolts or similar.

In addition, we have experienced, in a few cases, that the original factory adjustment of the block-type bearings in the chain drive, and the camshaft fitted bolts or their flange holes were not manufactured according to the specified tolerances.
