**Piston Ring Expander Claw**  
80-bore engines

SL2014-591/PRP  
June 2014

Owners and operators of MAN B&W two-stroke marine engines.  
Type: G/K/S80ME-C/MC-C/MC

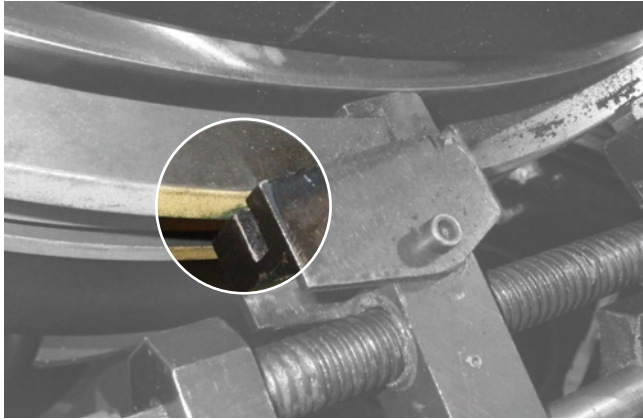
The latest version of the CPR piston rings for our large bore engines features a shorter “finger lock”. This does not comply with the current length of the claw on the piston ring expander tool, which results in contact between the tool and the piston ring. This can harm the coating on the piston ring, see Fig. 1. Damage to the piston ring coating will lead to reduced lifetime.

Fig. 1: Undesirable contact between piston ring and expander tool

The issue is not likely to occur before new piston ring spare parts are delivered. We therefore recommend that you rectify the tool when convenient. The following minor modification to the tool solves the problem; shortening the length of the claws to approximately 55 mm allows the piston ring to

fit inside the groove in the claws as originally intended. The length of the claw is typically 60 or 70 mm. An example of the modification is illustrated in Fig. 2.

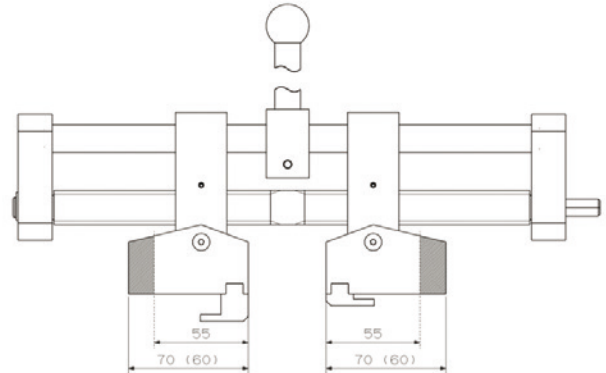
Fig. 2: The crosshatching indicates the area that needs to be cut off to obtain compatibility between the new piston ring finger lock and the expander tool
