Lubricating Oil Consumption

SL14-594/KEL December 2014

Owners and operators of MAN four-stroke diesel engines. Type: L23/30H GenSet

Modification of valve roller guide L23/30H

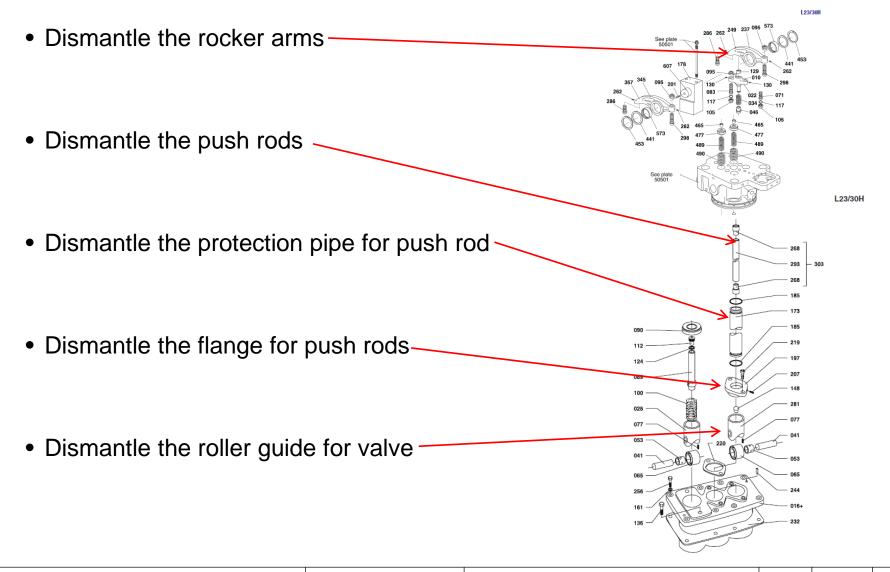
Occasionally, a high rate of lubricating oil consumption has been observed on the engine type L23/30H. MAN Diesel & Turbo has investigated the cause of the high lubricating oil consumption and found it to be the result of too high a lubricating oil level in the top cover. A too high lubrication oil level will cause too high lubricating oil drainage between valve spindles and valve guides.

In some cases, overhauls have revealed a large build-up of coke deposits on the valve cones and exhaust channels originating from the excessive flow of lubricating oil flowing from the valve guides.

A normal – and low level of lubricating oil in the top cover has been ensured by adding one extra drain hole in the roller guide draining to the oil sump. The existing roller guides can be modified by crew. A guideline for the modification is enclosed with this Service Letter. The new modified valve roller guides can be ordered from our PrimeServ sales organisation.

Dismantle the locking screw

Dismantle the pin and roller

Punch mark opposite side of the existing drain hole

Drill an 8-mm hole
