Maintenance and Pressure Test of Lube Oil Cooler

SL2015-602/NLC
 August 2015

Owners and operators of
 MAN four-stroke diesel engines.
 Type: L16/24, L21/31, L27/38, L23/30H,
 L23/30A, L28/32H, L28/32A, V28/32H

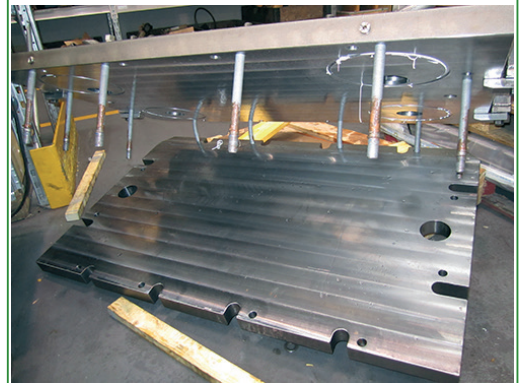
Warning

Never tighten / untighten bolts or nuts on a pressurized plate cooler.
 Doing so may cause the bolts / nuts to fail due to overload.
 Damaged bolts / nuts must be replaced.
