Updated Crosshead Bearing Design

For K98 and K/L90 engines

SL2016-613/NIHE

March 2016

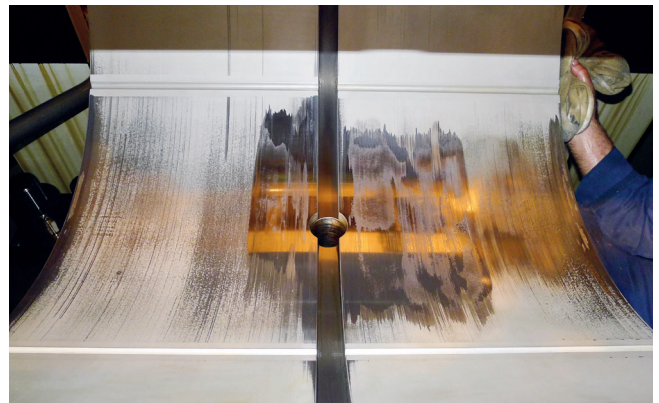
Figure 1: Bearing of modified design at 11620 hrs.

where it is seen that some redistribution of the lead overlay has occurred during the test period. This is a normal and acceptable sign of adaption between the surfaces. Otherwise, the bearings have nice appearances without any signs of fatigue cracks. As a consequence of the successful service tests, the updated design is the new standard for K98 and K/L90 engines. The bearing upper shell design has not been modified.

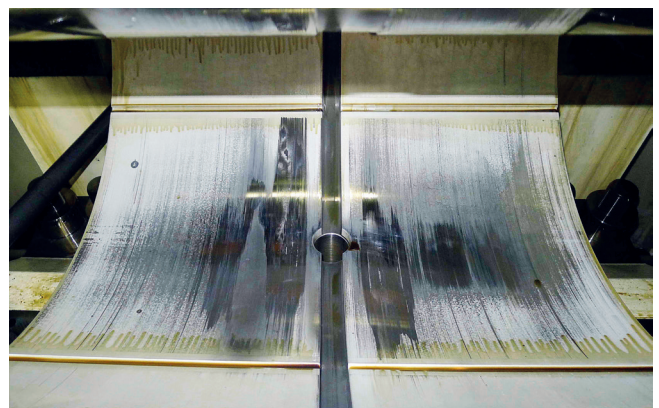
Figure 2: Bearing of modified design at 12012 hrs.
