**Product Safety Warning
- Updated Information**

Total Solutions & Power (TSP) accumulators

SL2016-616/PRP
May 2016

Product safety warning letter concerning accumulators produced by TSP.

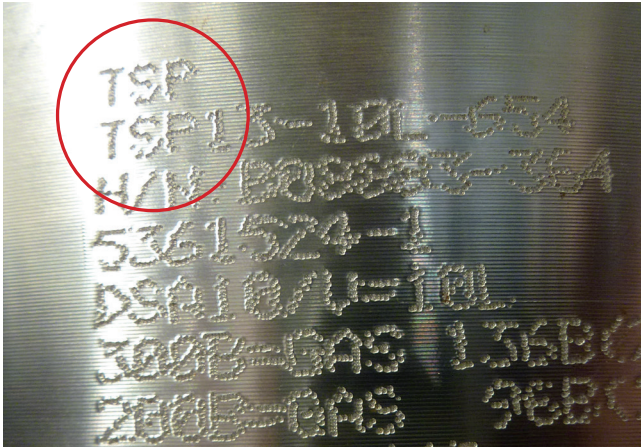
Fig. 1: TSP accumulator

The TSP accumulator can be identified as shown in Fig. 1.

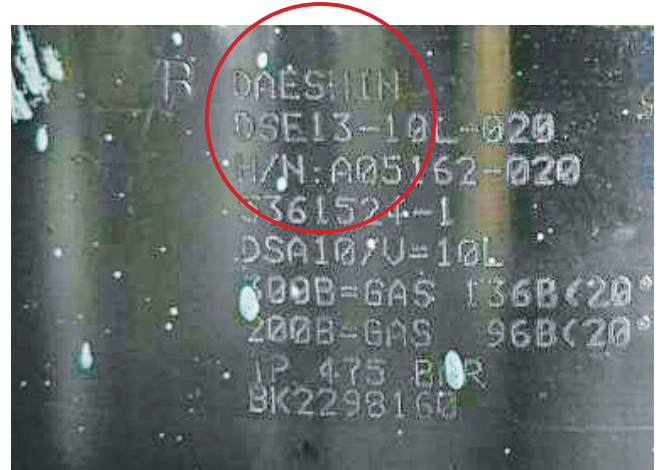
Fig. 2: 10L accumulators produced in 2013

TSP produced 10L accumulators in 2013 which are marked Daeshin, see Fig. 2. These must also be exchanged.
