### Lifetime of Fixed Cylinder Pressure Sensors

SL2016-621/CLN  
August 2016

Owners and operators of MAN B&W two-stroke marine diesel engines fitted with online cylinder pressure monitoring

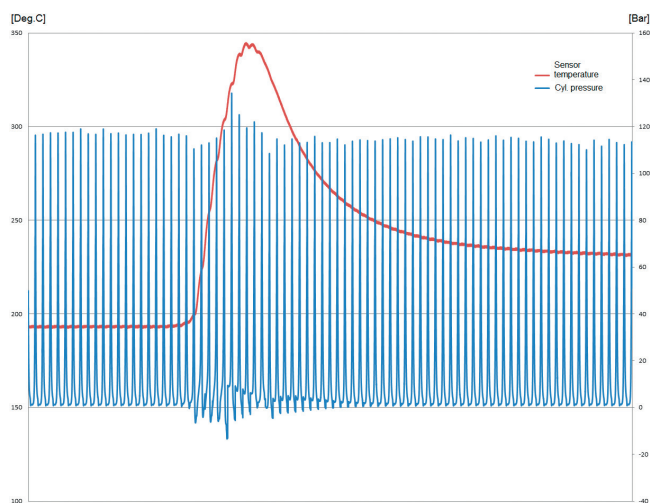
The sensor housing temperature increases dramatically when the indicator valve is open. This causes drifting of the sensor signal or even damage to the sensor if the period with blowing through is excessively long. Depending on the actual engine load and the duration of a previous period of blowing through of the indicator valve, the measuring results can be influenced up to 10 minutes after the indicator valve has closed and, therefore, they are potentially incorrect during this period.

Fig. 1: Sensor core temperature and pressure signal during indicator valve blow through

Blowing through the indicator valve for more than one engine revolution or a leaking indicator valve may lead to faulty measurements, reduced lifetime of the sensor and even sensor failure.

In general, it is recommended only to open the indicator valve while the starting valves are open and the engine is turned by air. Indicator pipes and valves clogged with exhaust/soot deposits should be cleaned manually before starting the engine.

Do not to blow through the indicator valve right before taking a manual calibration measurement. If clogging is suspected, blow through the indicator valve at low load for maximum 1 engine revolution. Disassemble and clean the valve manually if it is still clogged.

Wait for minimum 10 minutes after the indicator valve has been blown through, before mounting the handheld pressure transducer to take a calibration measurement.

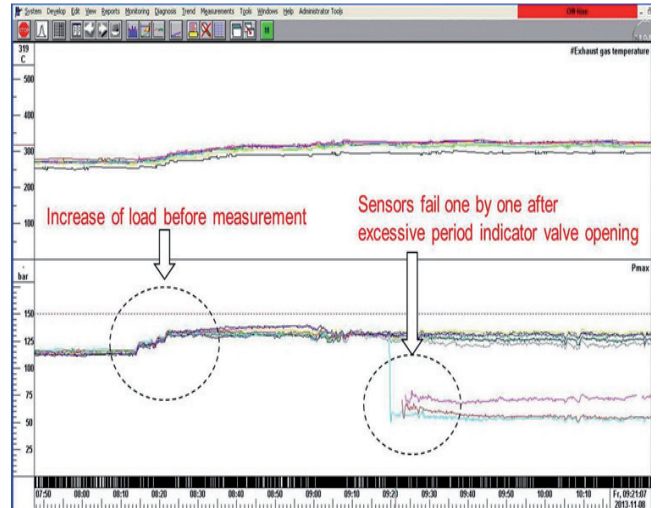
Fig. 2: Incorrect measuring procedure where the engine load is first increased, followed by an excessively long period with open indicator valve

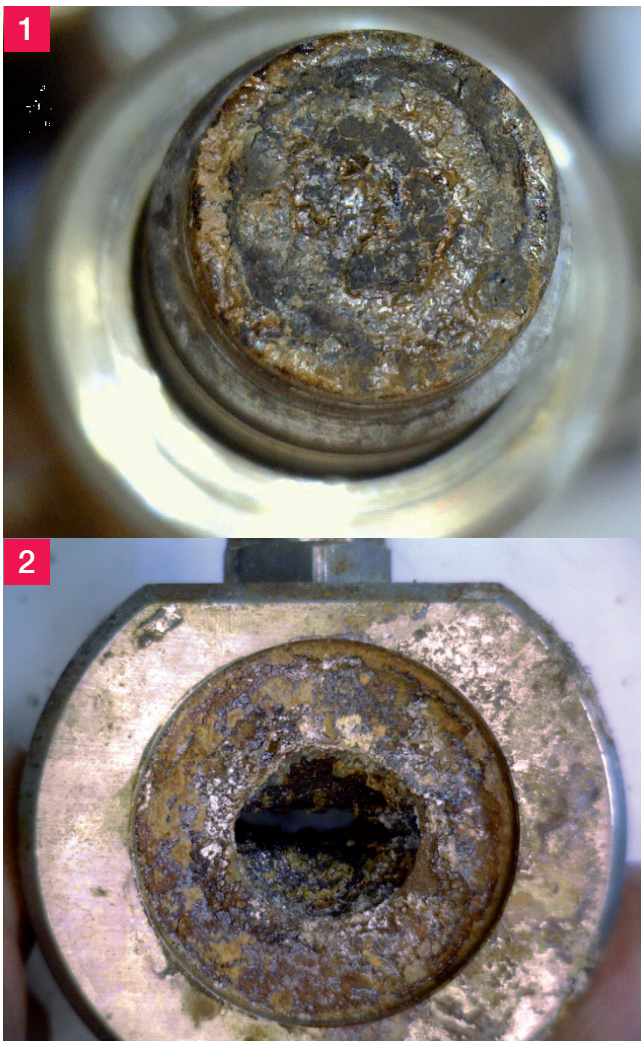
Investigation of the sensors returned to Kistler showed signs of extreme corrosion of the stainless steel, both on the sensor element itself and also on the sensor adapter.

Fig. 3: Corroded sensor (1) and adapter (2)

An inspection of the sensors and indicator pipe arrangements on board the vessel showed severe corrosion on all parts in the indicator pipe arrangement, including sealings, sensors and adapters. The inspection on board revealed that the vessels in question were mainly operating the engine at low load, and this load pattern combined with missing insulation on the indicator pipe arrangement led to low temperatures in the indicator pipe, in this way causing condensation of water with a high level of sulfuric acid. This was confirmed by temperature measurements on board, and further investigations of deposits performed by MAN Diesel & Turbo.

Ensure that the indicator pipe arrangement is insulated at all times in order to raise the temperatures above the acid dew point.

Divert the air from the blower inlet away from the cylinder covers on the engine.

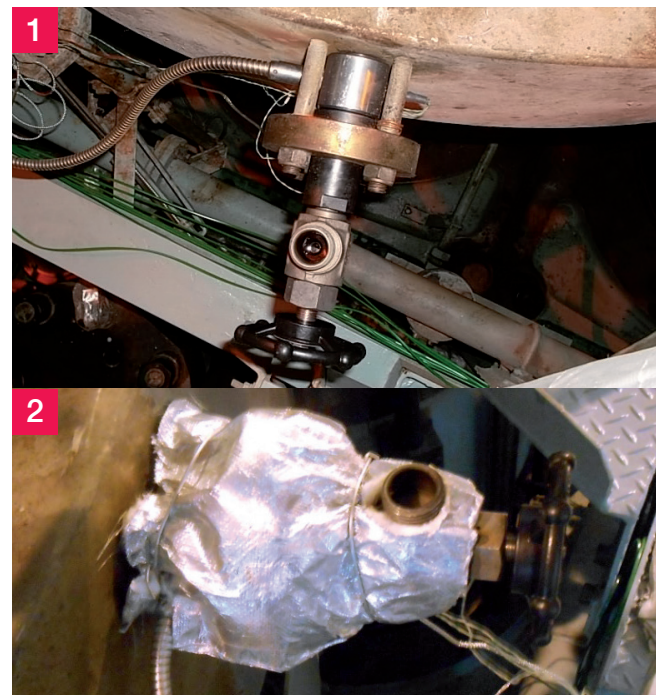
On-board measurements at low load also showed that insulation of the indicator pipe arrangement increased the temperature of the sensor by approximately 20 degrees. Furthermore, the cylinders for which most failures were reported were located directly below the fresh air blower, leading to further cooling of the indicator pipe arrangement.

Fig. 4: Indicator pipe with water condensation (1) and with insulation (2)
