Cooling Water Treatment and Periodical Test of the Cooling Water

SL2016-623/JFH July 2016

Owners and operators of MAN four-stroke diesel engines. Type: Propulsion and GenSet

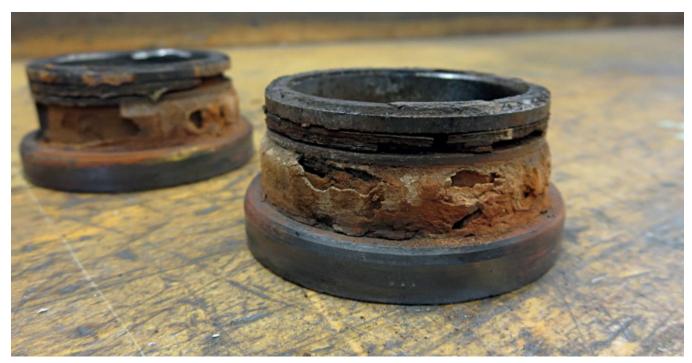
Fig. 1: Rust and limescale fill up the cooling space of the exhaust valve seat ring, and the O-ring has become hard and brittle

In general corrosion may result in leakages and thereby reduce the lifetime and safety of the engine components. Limescale as well as rust deposits will reduce the heat transfer and may result in thermal overload of the components to be cooled by the engine cooling water. A thermal overload may, however, also result in cracks and leakages as seen in the exhaust valve seat ring.

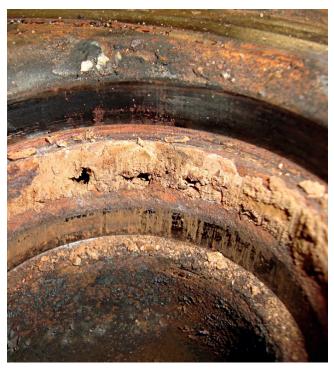
The damages are often a result of corrosion, restrictions in or blocking of the cooling water flow, which are caused by deposits of limescale and/or rust.

Fig. 3: Rust and limescale blocks the cooling water bores (valve seat removed from cylinder head)
