Gas-tight Lock
Top Piston Ring

SL2016-625/AAB
September 2016

Owners and operators of MAN B&W two-stroke marine diesel engines with semi-high or high piston top-land. Type: MC/MC-C/MC-S, ME/ME-C, ME-GI/ ME-GI-S and ME-B

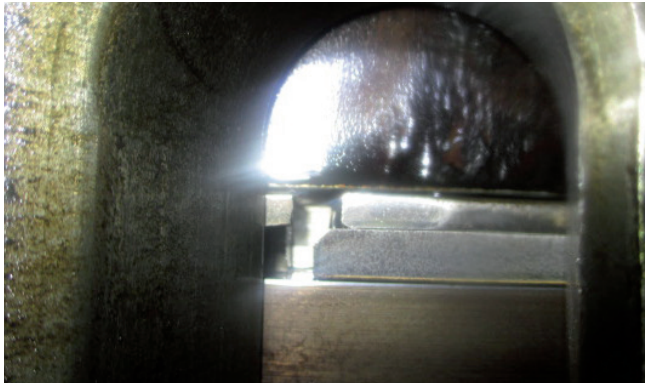
Fig. 1 shows a well run-in top piston ring, except for the broken gas-tight lock.

Fig. 1: Top piston ring with a broken gas-tight lock

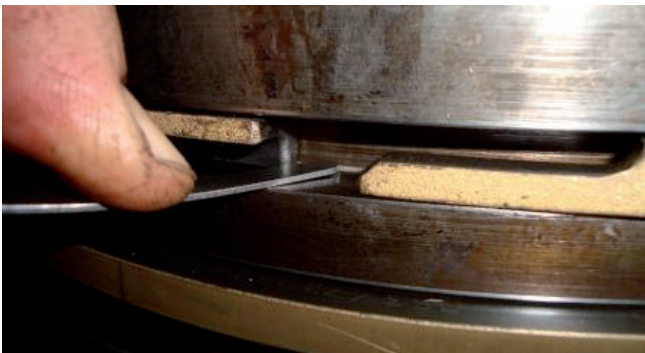
The Figs. 2 and 3 show the effect of running with an excessive ring groove clearance.

Fig. 2: Excessive ring groove wear and gap in the gas-tight lock

If the piston crown ring groove wear exceeds the figures given in the manual, the crown must be replaced by either a reconditioned or a new crown.

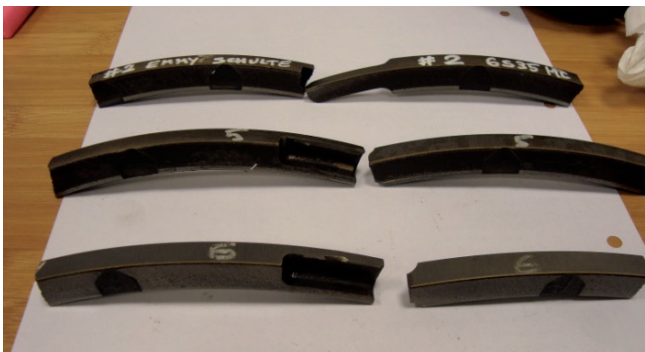
Fig. 3: Excessive ring groove wear and missing contact between groove and ring resulted in worn-out piston rings with gaps in the gas-tight lock

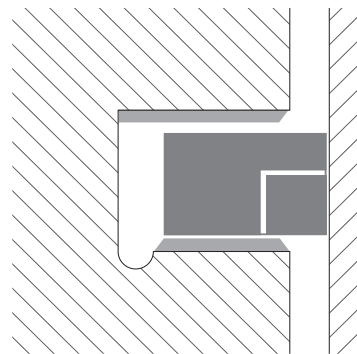
Fig. 4 illustrates the induced stress on the gas-tight lock, happening when a cylinder unit is operated with a too large piston-crown ring-groove clearance.

Fig. 4a: New top piston ring (gas-tight lock is shown) and new piston crown

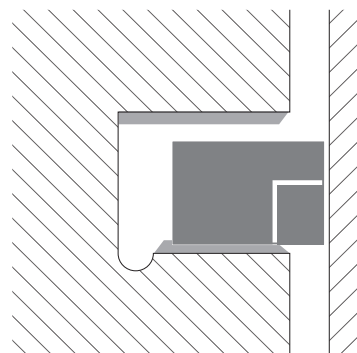
Fig. 4b: After running

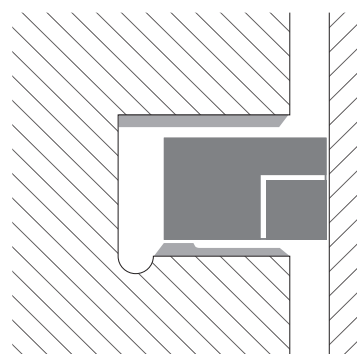
The explanation is simple, in particular for the top rings. The excessive ring groove clearance for the top ring causes stress on the weaker gas-tight lock of the top ring to increase significantly.

Fig. 4c: After overhaul with a new top piston ring, the result will be elevated stress in the gas tight lock due to the excessive ring-groove wear

In general, such operational conditions should be avoided by monitoring the total amount of vertical clearance for all rings on a regular basis.
