Potential Crack in Piston Crown

- in inner circular contact flange

SL2016-626/SBJ
September 2016

Owners and operators of MAN B&W two-stroke marine diesel engines.
Type: S70MC

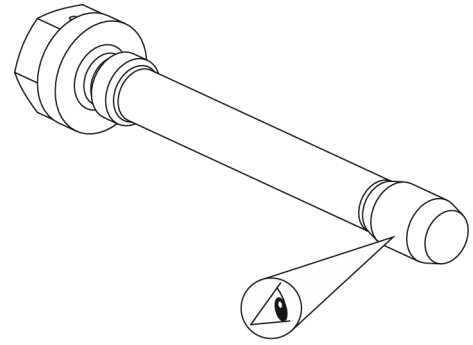
8865-4204-0001C05

5. Check the thread end of the screw for signs of deformation or hard contact.

8. If the screw shows signs of deformation or hard contact, as checked in step 5, OR if a gap is found between the reference screw and the piston rod flange, then the piston MUST be removed from the cylinder as described in the dismantling section of this S-instruction.
- Subsequently the piston crown MUST be scrapped.
9. If the screw shows no signs of deformation or hard contact, as checked in step 4, AND no gap is found between the reference screw and the piston rod flange, the piston can be removed from the engine and overhauled using the standard piston instruction M90201 or 2265-0401.

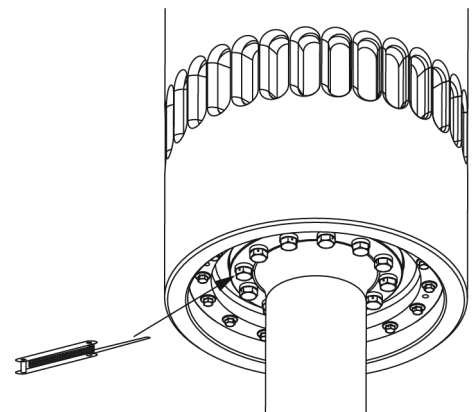
8865-4204-0001C07

7. Using a 0.05 mm feeler blade check the full circumference of the contact face between the reference screw and the piston rod flange.

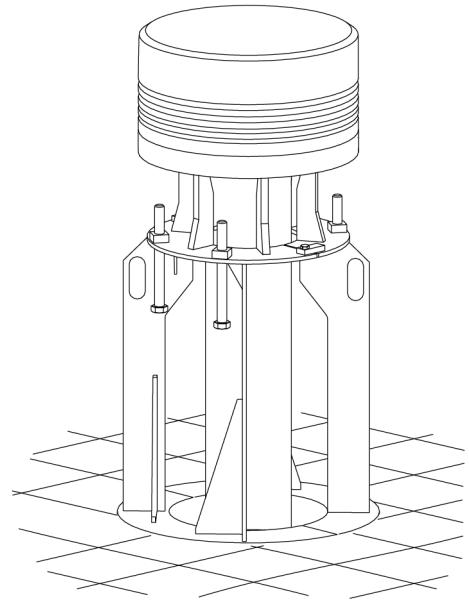
2265-0401-0001C07

A damaged piston crown (as described in the checking section of this S-instruction) can NOT be re-used or reconditioned.

The piston MUST be mounted in the support iron during dismantling of the piston crown and mounting of the new piston crown.
