**New recommendation for grinding angle of exhaust valve spindle**

SL2019-682/JAG  
October 2019

Owners and operators of MAN B&W two-stroke marine diesel engines.  
Type: All 30-98 bore engines

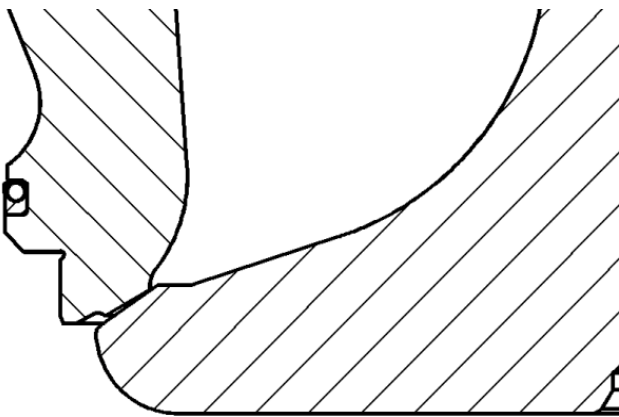
Previous

The exhaust valve spindle is not actively cooled, but the contact to the bottom piece seat is a cooling contribution to the spindle seat. The “wide seat” design features a contact area between the spindle seat and the bottom piece seat which is meant to improve the heat transfer from the uncooled spindle to the water-cooled bottom piece.

However, service inspections have shown that the predominant contact pattern between spindle seat and bottom piece seat is an inner contact rather than near full contact as intended.

**New grinding angle for spindle seat 30.2° +0.05/-0**

Note: this applies to spindles serviced in bottom pieces of both W-seat and wide-seat designs. The seat angle for the bottom piece keeps the 30 degree but with new tolerance 30.0° +0/- 0.05.

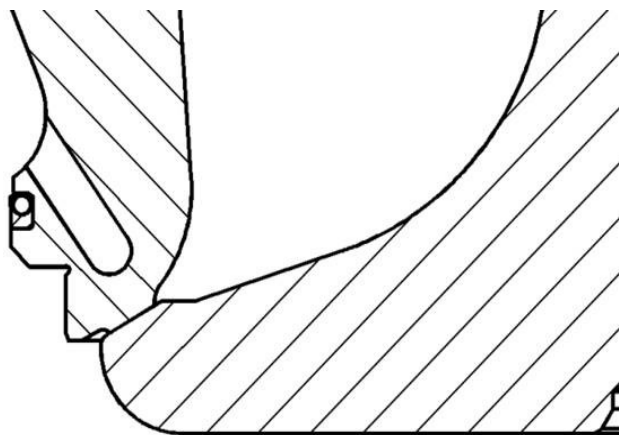
Present - bore cooled

Further advance of spindle seat cooling can also be obtained by applying the new “bore-cooled” bottom piece.
