**Inlet pressure settings for air starters**

SL2020-696/JNN  
May 2020

**Concerns**

Owners and operators of  
MAN four-stroke diesel engines.

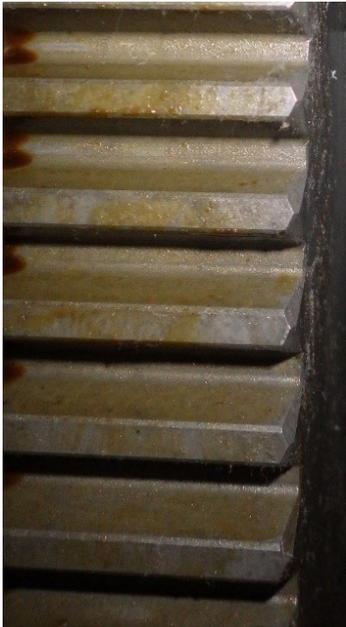
In case of unfavorable pressure conditions before the starter, there is a risk of reengagement of the starter pinion drive during the starting sequence; also called bouncing pinion. In such a case there is a risk that the turning torque can be applied to the pinion drive when this is only partly engaged, hereby causing deformation to the teeth of the starter gear rim on the flywheel.

Example of indent marks, observed at the tip of the teeth on the starting gear rim, caused by reengagement of the pinion drive

Our recommendation for the air starting pressure is to keep the inlet pressure at 7-9 bar. However, due to the above observations, we recommend to keep the pressure at the upper limit of 9 bar to ensure optimum performance of the air starter.

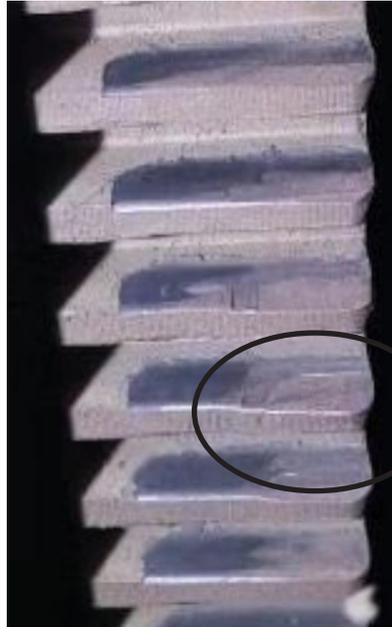
The observed damage may extend further and can lead to starting failure if starting of the engine is continued with unfavorable pressure conditions.

Example of new gear rim and a gear rim with damage
