Fretting in main bearing bore

SL2020-706/JNN

November 2020

ConcernsOwners and operators of
MAN four-stroke diesel engines.

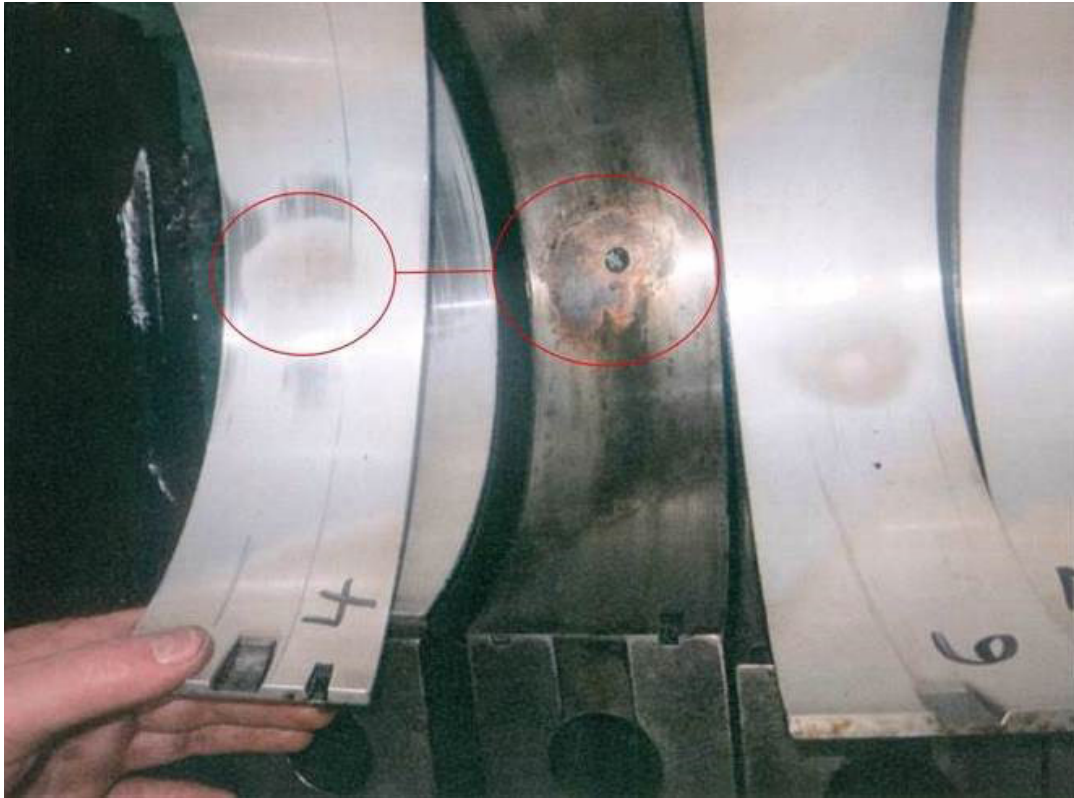
In service we occasionally observe fretting / corrosion between the main bearing shell and the main bearing cap at engines without main bearing temperature sensors installed.

The fretting / corrosion is caused by relative movement of the bearing shell and cap during engine operation, in this connection water and oil can migrate between bearing shell and cap through the sensor hole and cause the observed wear patterns at the bearing running surface.

Fig. 1. Example of fretting / corrosion and related visible imprint at the main bearing shell.

Depending at the extension of the fretting / corrosion it may be possible to dress up the main bearing cap by controlled hand grinding of this.

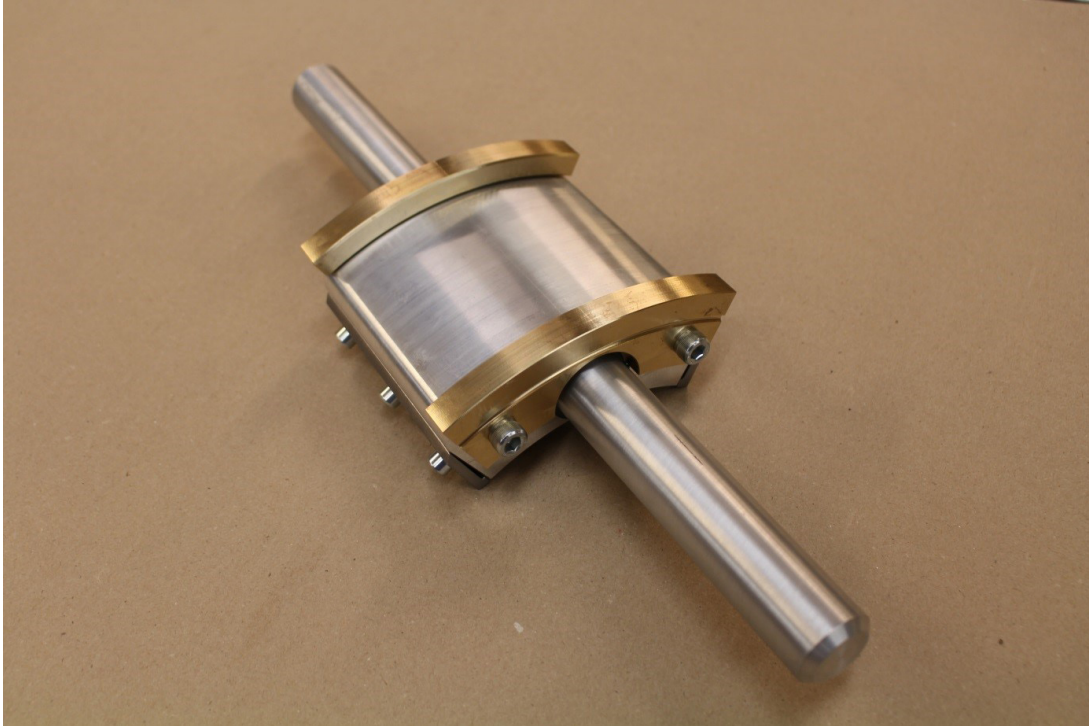
Fig. 3. Example of tool for dressing work

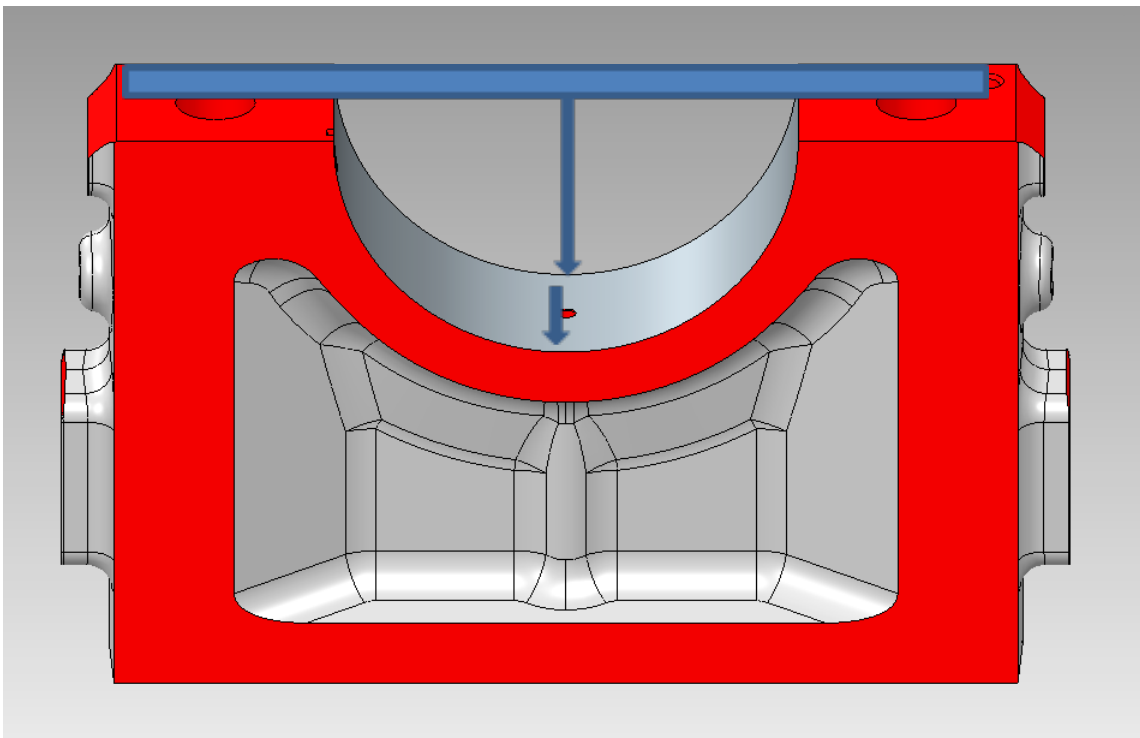
Fig. 4. Two reference measurements must be taken before the dressing work is initiated

Before the dressing work is started two reference measurements are to be taken at each side of the main bearing cap in order to be able to check the depth of the performed dressing, see Fig. 4.
