This service letter applies to MAN B&W two-stroke marine diesel engines of the MC/MC-C type.

Alpha Lubricator

Service Experience

SL2016-632/AAB November 2016

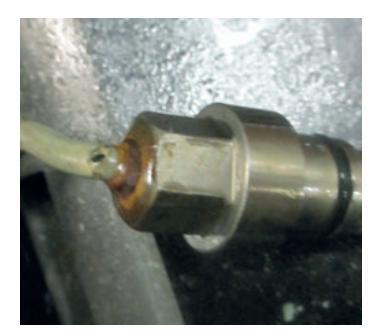
Fig. 2a: Defective feedback sensor

As a defective sensor may cause oil to enter the junction box and printed circuit boards (PCB), attention should be paid to the condition of the feedback sensor, see Figs. 2a and b showing a faulty feedback sensor.

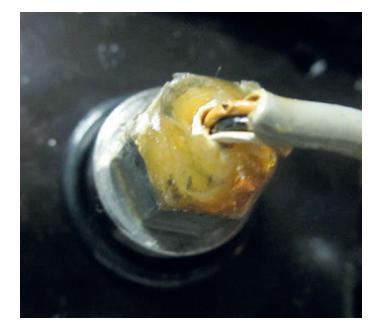
Fig. 2b: Defective feedback sensor

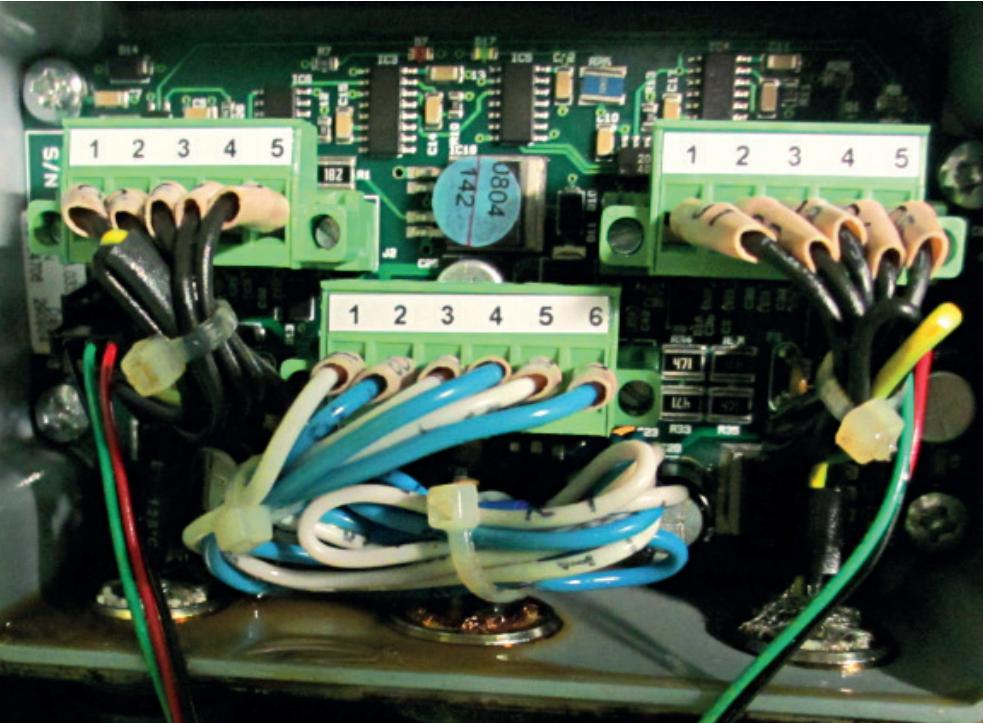
Fig. 2c: Oil in junction box and PCB for feedback loop due to the defective sensor

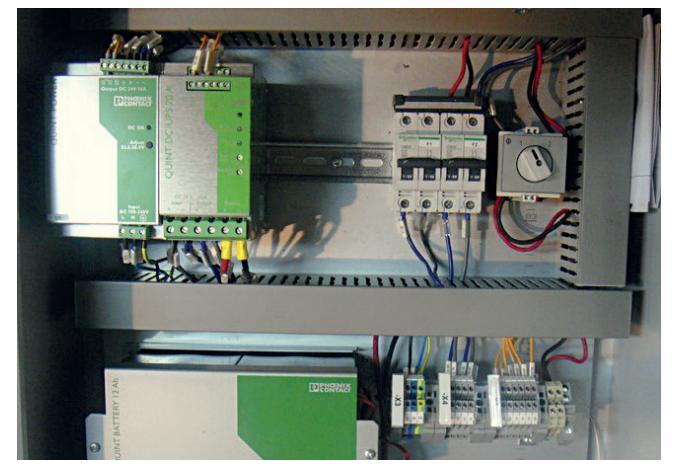
Fig. 3: The 24 V stand-alone power supply with UPS

Based on feedback from vessels with Alpha lubricator units in service, we have, in addition to the above, observed that a large part of the experienced difficulties, including damage to PCBs (i.e. the master control unit (MCU), backup control unit (BCU) and switch board unit (SBU)), can be ascribed to the fact that the 24V power supply to the Alpha lubricator system is made through the ships common supply.

Our standard and specified system includes a stand-alone 24 V supply with uninterruptable power supply (UPS), see Fig. 3. If installed, such a system will improve the margin to failures, false alarms and damage to PCBs contrary to an installation connected to the common 24 V supply system on board.

We recommend that the mentioned stand-alone power supply with UPS is installed when convenient. Technical questions should be submitted to: dt-cph@mandieselturbo.com.
