Regular dp-RTV and RTV position check of SCR installations

SL2022-727/JSST August 2022

Owners and operators of MAN B&W two-stroke marine diesel engines. Type: MC/MC-C and ME/ME-C

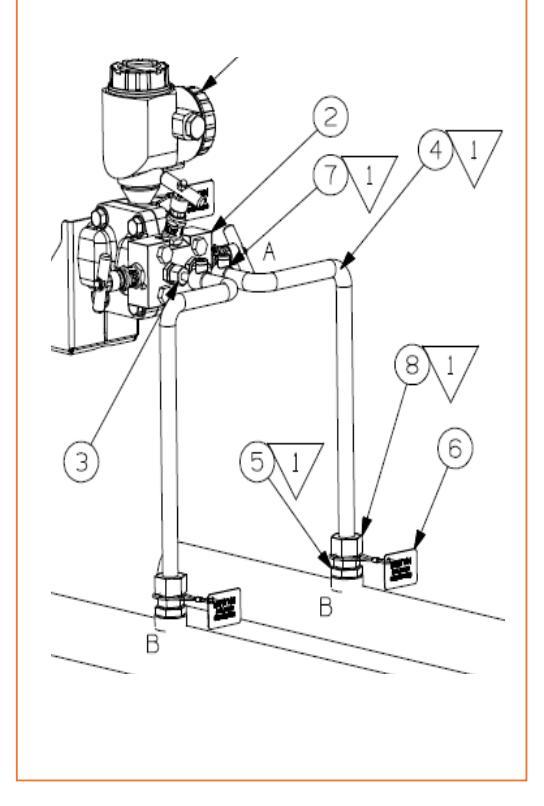
Early designs with smaller copper pipes connected to the dp-sensor (PDT6615) sometimes get clogged, resulting in high dp-readings (above 0.3 bar in most installations). This causes the RTV to open even though there might not be an actual pressure difference.

Fig. 1: dp-RTV is above specified opening value and RTV is given 6% SP open signal

It is recommended to inspect the dp-RTV and the position of the RTV on a weekly basis. If the dp-RTV is higher than the predefined value (usually 0.2-0.3 bar at stable load when in Tier II mode), the RTV should be opened to pressure-equalise. If the pressure does not decrease and the valve does not close again within 90 seconds, dismantle the copper pipes to the dp-sensor for cleaning, and check that the sensor membrane is clean. If the problem persists, contact MAN Energy Solutions for further troubleshooting at OperationEmissionTechnology2S@man-es.com

If the valve is already open at the initial check, a reactor inspection is highly recommended.

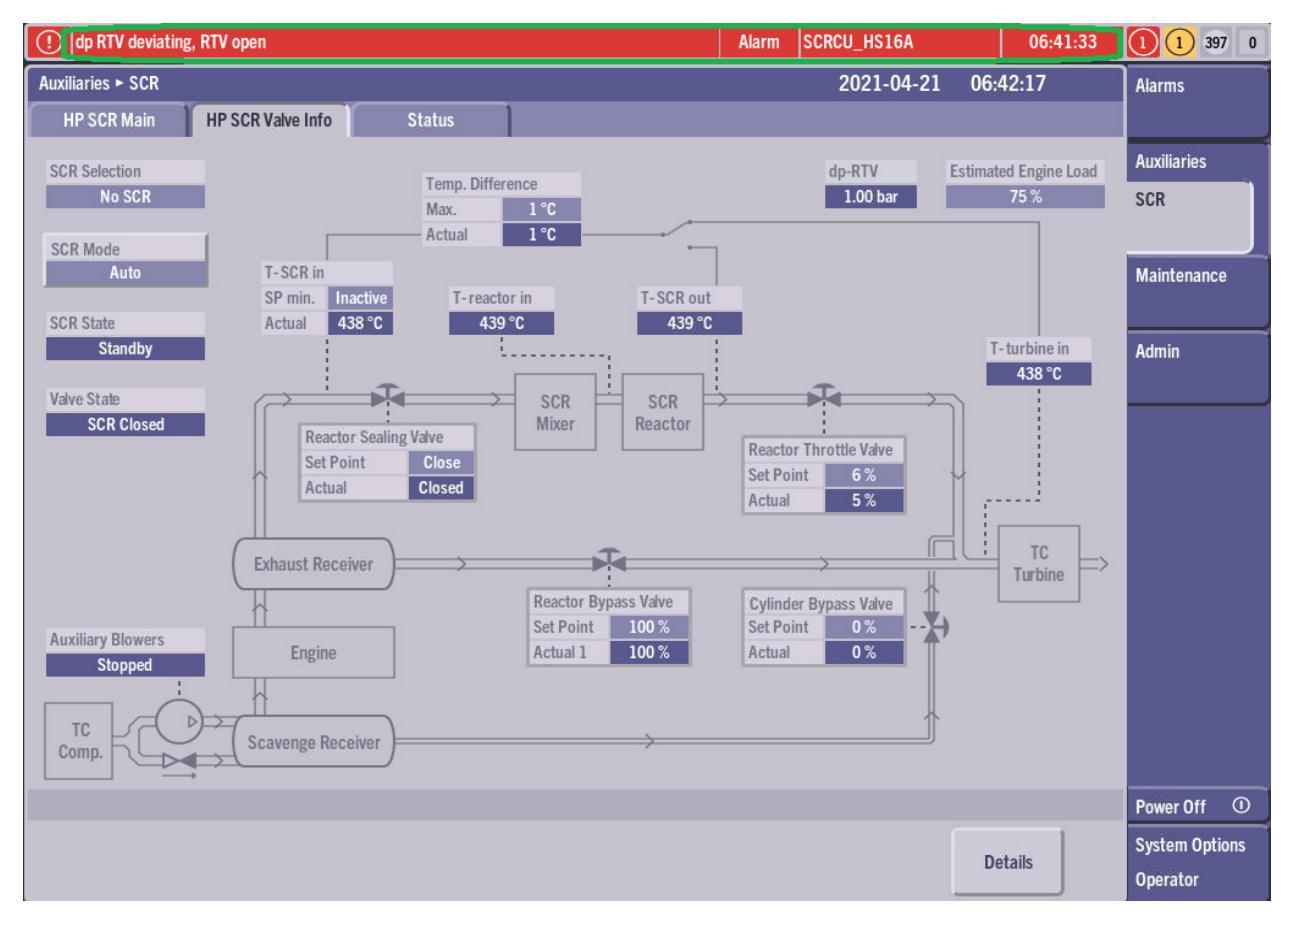
If the dp-RTV is higher than 0.3 bar or below -0.3 bar while the RTV is more than 4% open, an alarm will notify the crew after a minute that something is wrong.

Fig. 2: In SW 2011-1.12, and later, the active alarm will be visible in case dp-RTV does not decrease after RTV been open for a minute or longer
