# Up-tower recovery

**MAN PrimeServ**

# Generator shaft recovery

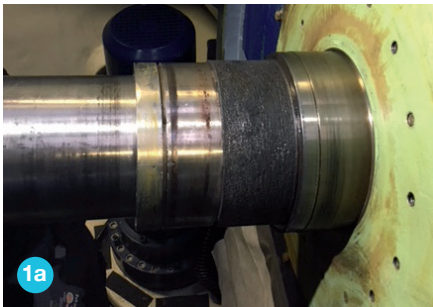
Different degrees of ball bearing seizure is the most frequent reason for damages to the generator shaft. For different wind turbine models of 2 MW and larger, we have the tools and the experience to perform up-tower recovery of the shaft.

- 1a Shaft damaged by bearing failure
- 2a Shaft after machining
- 3a Sleeve fitted after machining
- 1b Part of bearing attached to shaft
- 2b Bearing partly removed
- 3b Sleeve fitted after machining

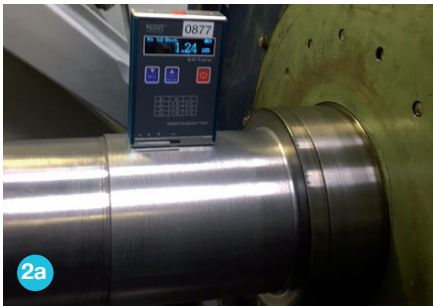
After machining the damaged shaft, the basis material is tested for micro cracks, hardness and roughness. Finally, a pre-made bushing is shrink-fitted to restore the original dimensions of the generator shaft. Complete recovery of the shaft to manufacturer's specifications is performed in three days.
