Lubricating Oil Consumption

SL14-594/KEL December 2014

Owners and operators of MAN four-stroke diesel engines. Type: L23/30H GenSet

Modification of valve roller guide L23/30H

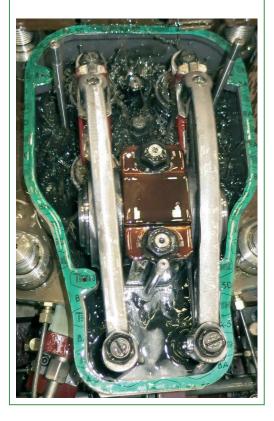
Occasionally, a high rate of lubricating oil consumption has been observed on the engine type L23/30H. MAN Diesel & Turbo has investigated the cause of the high lubricating oil consumption and found it to be the result of too high a lubricating oil level in the top cover. A too high lubrication oil level will cause too high lubricating oil drainage between valve spindles and valve guides.

In some cases, overhauls have revealed a large build-up of coke deposits on the valve cones and exhaust channels originating from the excessive flow of lubricating oil flowing from the valve guides.

Too high lubricating oil level in the top cover can cause increased lubricating oil consumption.

A normal – and low level of lubricating oil in the top cover has been ensured by adding one extra drain hole in the roller guide draining to the oil sump. The existing roller guides can be modified by crew. A guideline for the modification is enclosed with this Service Letter. The new modified valve roller guides can be ordered from our PrimeServ sales organisation.
