Potential Crack in Piston Crown

- in inner circular contact flange

SL2016-626/SBJ
September 2016

Owners and operators of MAN B&W two-stroke marine diesel engines.
Type: S70MC

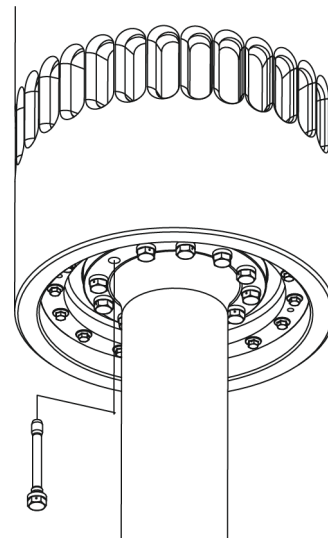
8865-4204-0001C04

5. Check the thread end of the screw for signs of deformation or hard contact.

8. If the screw shows signs of deformation or hard contact, as checked in step 5, OR if a gap is found between the reference screw and the piston rod flange, then the piston MUST be removed from the cylinder as described in the dismantling section of this S-instruction.
- Subsequently the piston crown MUST be scrapped.
9. If the screw shows no signs of deformation or hard contact, as checked in step 4, AND no gap is found between the reference screw and the piston rod flange, the piston can be removed from the engine and overhauled using the standard piston instruction M90201 or 2265-0401.

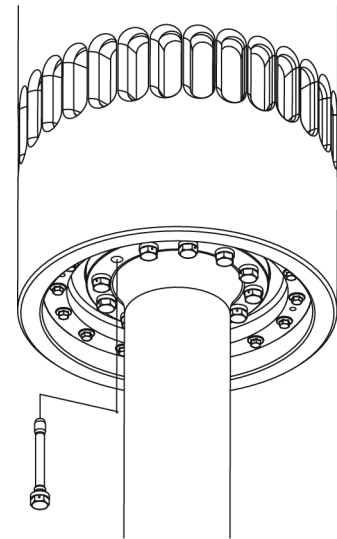
8865-4204-0001C04

7. Using a 0.05 mm feeler blade check the full circumference of the contact face between the reference screw and the piston rod flange.
