**Inlet pressure settings for air starters**

SL2020-696/JNN  
May 2020

**Concerns**

Owners and operators of  
MAN four-stroke diesel engines.

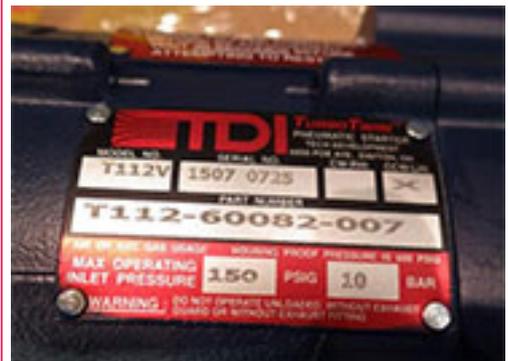
Our Service Department has reported early deterioration of the starter gear rim on some engines in service. According to our investigations the observed deterioration is caused by unfavorable starting air pressure before the engine.

In case of unfavorable pressure conditions before the starter, there is a risk of reengagement of the starter pinion drive during the starting sequence; also called bouncing pinion. In such a case there is a risk that the turning torque can be applied to the pinion drive when this is only partly engaged, hereby causing deformation to the teeth of the starter gear rim on the flywheel.

The observed damage may extend further and can lead to starting failure if starting of the engine is continued with unfavorable pressure conditions.

Example of indent marks, observed at the tip of the teeth on the starting gear rim, caused by reengagement of the pinion drive

Example of new gear rim and a gear rim with damage

Our recommendation for the air starting pressure is to keep the inlet pressure at 7-9 bar. However, due to the above observations, we recommend to keep the pressure at the upper limit of 9 bar to ensure optimum performance of the air starter.
