Reaming of valve guide after replacement

SL2021-716/JOHP
September 2021

Concerns

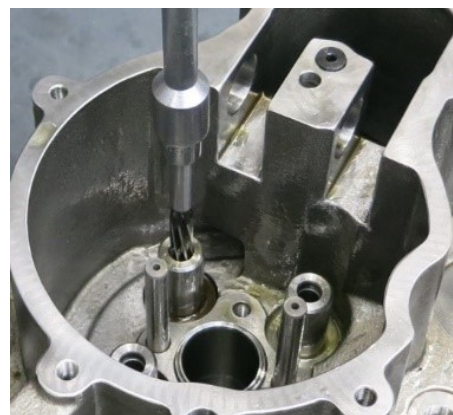
Reamer for valve guide

Engine type	Plate / Item no.
L16/24	P52002-09 / 748
L23/30	P52002-12 / 748
L21/31	P52002-10 / 748
L27/38	P52002-11 / 748
L/V28/32	P52002-14 / 748 P62002-02H / 748

The valve guide must be reamed to ensure that it has the correct dimension when installed in the cylinder head.

A reamer for valve guides is not a part of the standard tool kit. The appropriate reamer can be ordered from MAN Energy Solutions using the Plate Item number shown in the table on the next page.
